<b>Name:</b>	COMMUNAL 1-75 Kennedy Gardens
<b>Address 1:</b>	COMMUNAL 1-75 Kennedy Gardens
<b>Address 2:</b>	Billingham
<b>Postcode:</b>	TS23 3RF
<b>Property Reference:</b>	42894
<b>Type of Fire Risk Assessment carried out:</b>	Type 1 Fire Risk Assessment: Common parts only (non-destructive)
<b>Responsible Person:</b>	Thirteen Group
<b>Competent Surveyor:</b>	Stu Simpson
<b>Survey Date:</b>	08/05/2025
<b>Surveyor Signature:</b>

# FIRE RISK ASSESSMENT RECORD FORM

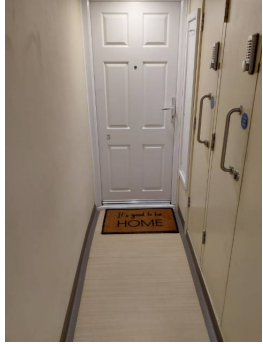
COMBUSTIBLE MATERIALS	Any build up of combustible materials? (E.g. paper, cardboard, wood, etc, or evidence of hoarding in or around residents' accommodation).	<b>Medium Risk - 28 days</b>	Scheme management, following consultation with the resident, to arrange for the removal of the door mat from outside flat No 3.

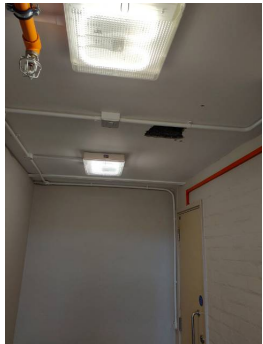
Are there any compartmentation issues. i.e. Has work taken place which may have made holes in walls or damaged any fire resistant ceilings/linings

**Medium Risk - 28 days**

The holes in the ceiling of the bin chute room, on the 10th floor, need to be addressed using suitable fire resisting materials.

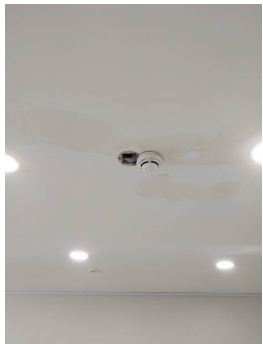
Are there any compartmentation issues. i.e. Has work taken place which may have made holes in walls or damaged any fire resistant ceilings/linings

**Medium Risk - 28 days**

The hole in the ceiling of the ground floor communal meeting room needs to be addressed using suitable fire resisting materials.

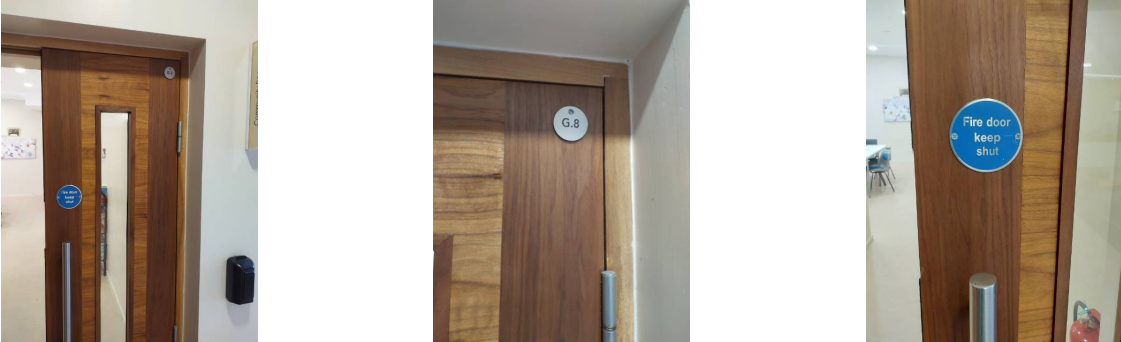
MEANS OF ESCAPE	Are fire doors on escape routes in a good state of repair and do they close fully into their rebates?	<b>Medium Risk - 28 days</b>	Door 1.10 - The handle has become detached from the riser cupboard door.

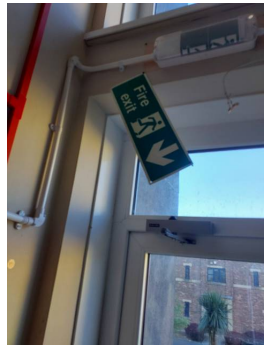
Have appropriate notices been put in place on final exit doors"? e.g Push to open, turn knob to open?

MEANS OF ESCAPE	Have appropriate notices been put in place on final exit doors"? e.g Push to open, turn knob to open?	<b>Medium Risk - 28 days</b>	Re-affix the Fire Exit sign, positioned above the first floor final exit door, that enables egress onto the metal external staircase.

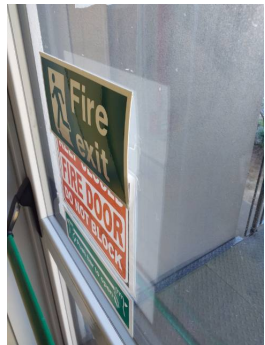
**Medium Risk - 28 days**

Re-affix the Fire Exit sign, affixed to the inner face of the first floor final exit door that enables egress onto the metal external staircase, as it is loose.

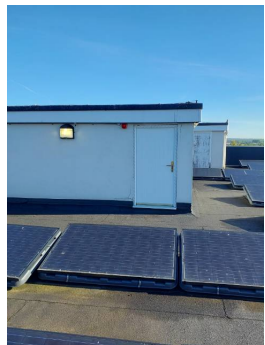
Is adequate signage in place?

**Medium Risk - 28 days**

Photoluminescent directional signage should be above the two exits at the roof level, to direct relevant persons into the secondary stair and the protected escape corridor on the 11th floor.

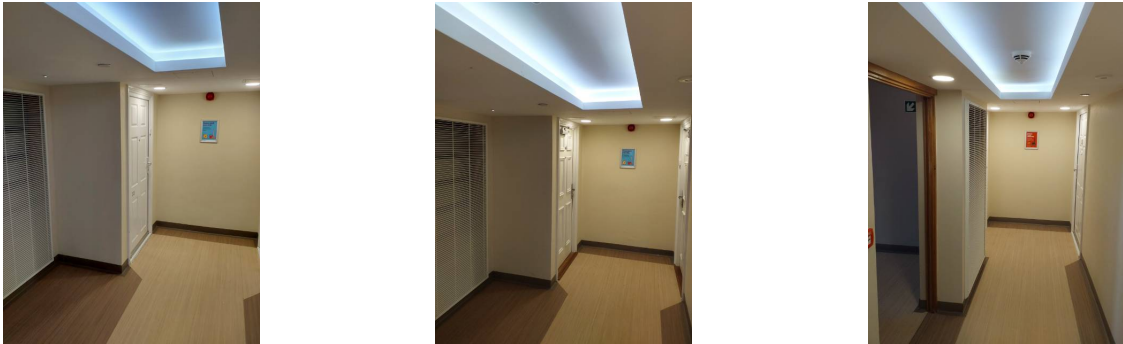
SIGNAGE	Is adequate signage in place?	<b>Medium Risk - 28 days</b>	Install directional signage to direct relevant persons into the secondary escape stair, from the main corridors, at all levels.

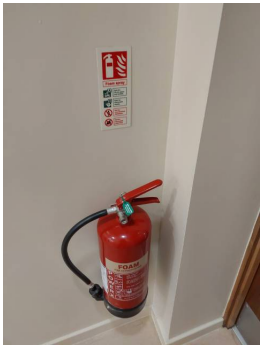
FIRE FIGHTING EQUIPMENT	Are the number and type of extinguishers appropriate to the risk?	<b>Medium Risk - 28 days</b>	The ground floor communal lounge is provided with a foam extinguisher. This extinguisher should be replaced with a risk appropriate extinguisher- water mist.

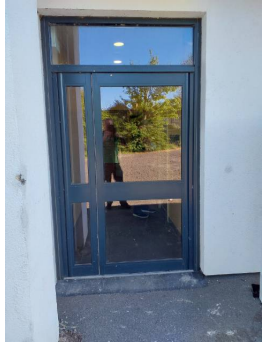
PREMISES RELATED	Is there an abundance of unnecessary fire loading in close proximity to the premises and available for ignition by outsiders?	<b>Medium Risk - 28 days</b>	Scheme management to arrange for the removal of the large fridge freezer, which is positioned on the external pathway in close proximity to the ground floor final exit door that exits the premises near to the internal wheelie bin store.
